MEDIEVALISTA

**Metal staples in the construction of the central building of  
the Belvoir fortress (Kokhav Ha Yarden, Israel)**

*Laurent D'Agostino*

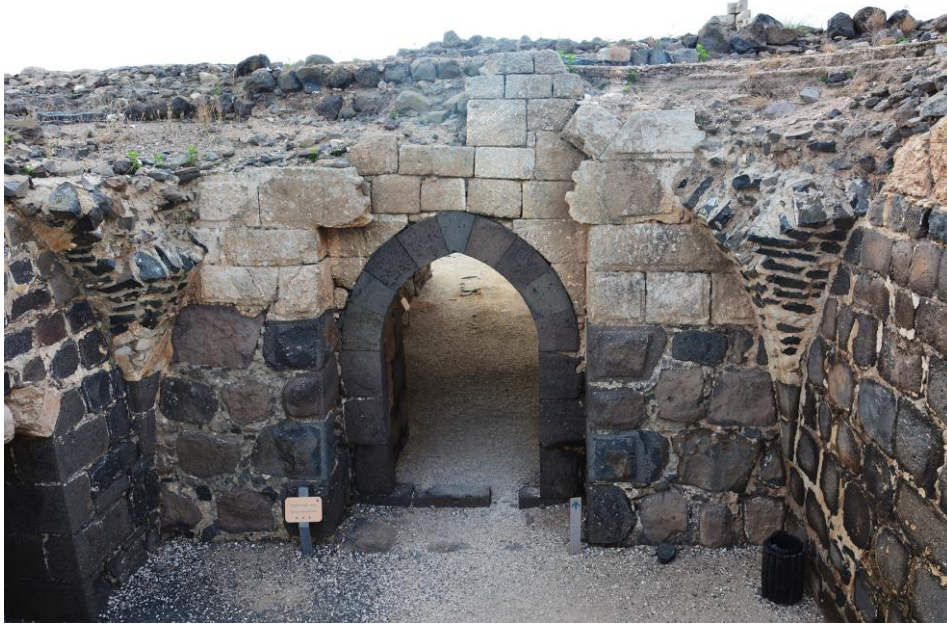
**Fig. 2 - West door of the inner building; basalt embankment and upper siding in limestone. (© L. D'Agostino).**

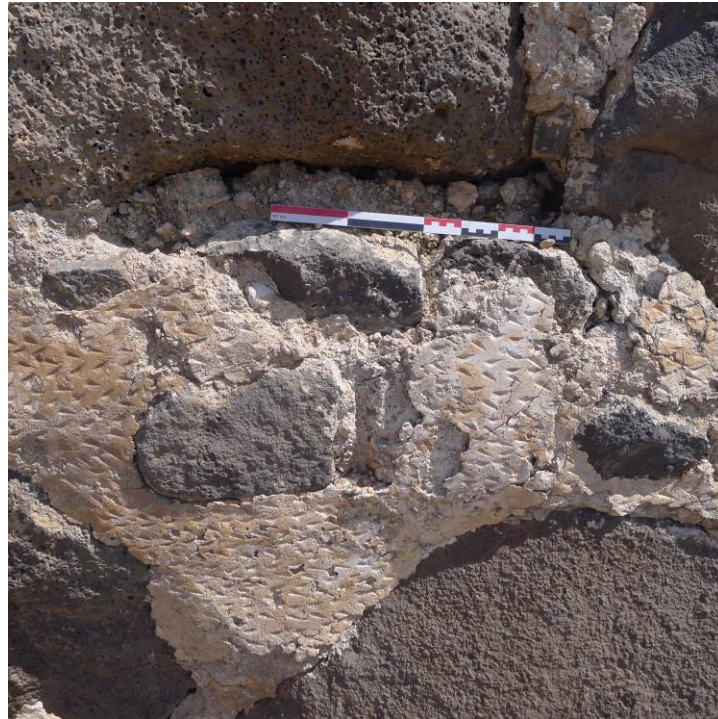
**Fig. 3 – Construction of cyclopean blocks, with joints of plaster with scale-shaped incisions. (© L. D'Agostino).**

This survey covered the entire exterior and interior elevations of the main building<sup>3</sup>. On the survey report provided by the photogrammetry, we systematically located the staples on two sides of the reduct: the eastern façade and the southern façade, as well as on the facings of the towers on the north-east and south corners<sup>4</sup>. A systematic visual analysis allowed us to identify the entire staples, which are few in number, and their sealing holes, which may still include either the lead sealant, or some metallic residue from the staple itself. Then, we used the metal detector to conduct reactivity tests on the staples still in place, which allowed us to adjust the sensitivity of the machine. In the end, to cover all the masonry, we did systematic scanning of the facings. In 2015, this research was extended to the entire central building of the castle (**Fig. 3**) and tests were carried out on the outer wall.

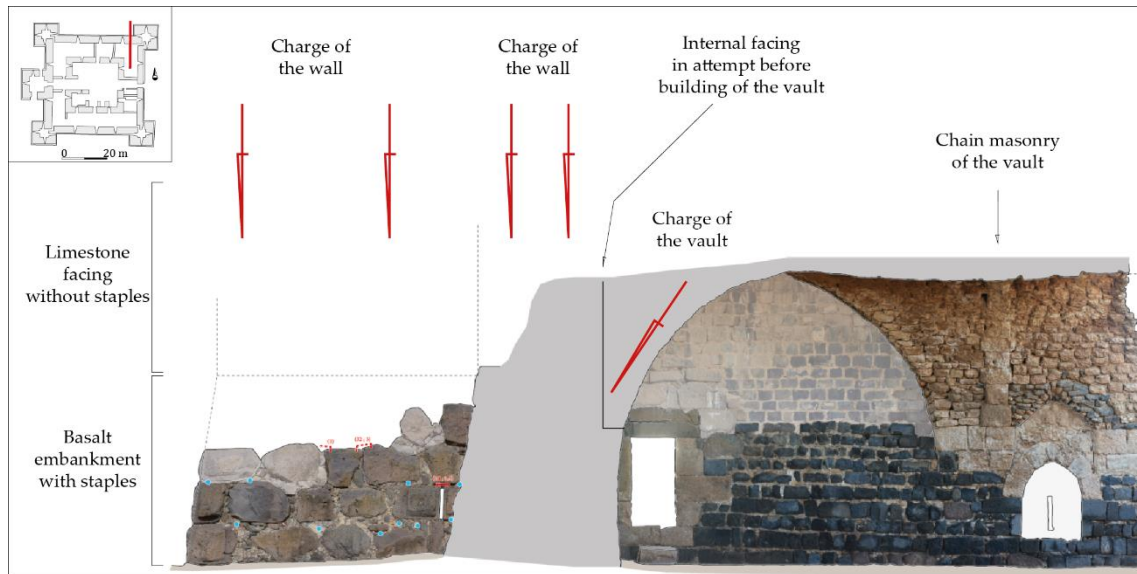
**Fig. 4 - Construction method of the central building of the castle of Belvoir (© L. D'Agostino).**

The external elevations of the Belvoir interior reduct show a very homogeneous construction method (**Fig. 4**). Whether at the level of the towers or the central building, the lower parts of the walls are systematically shaped as embankments built with large blocks of rough or split basalt whose dimensions range from 73 by 31 cm to 90 by 145 cm or 102 by 124 cm (**Fig. 5**). While the courses are adjusted, the variable shapes of the blocks require the use of many smaller elements, of shards of basalt or sometimes limestone, to shim the cyclopean blocks; the joints are then completely covered with a plaster with scale-shaped incisions (**Fig. 6**).

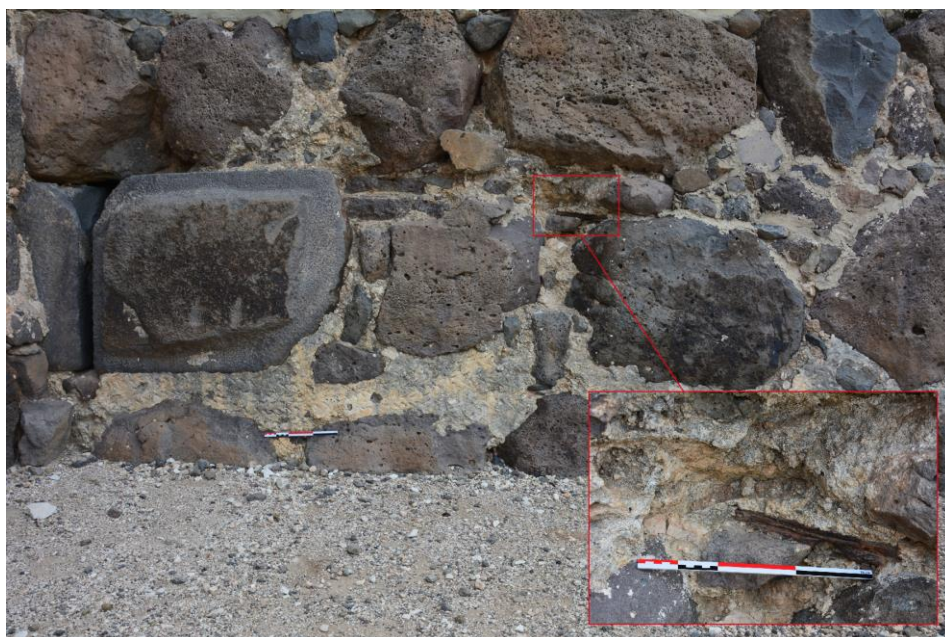
**Fig. 5 - Iron staple between two blocks of basalt (© A. Baud).**

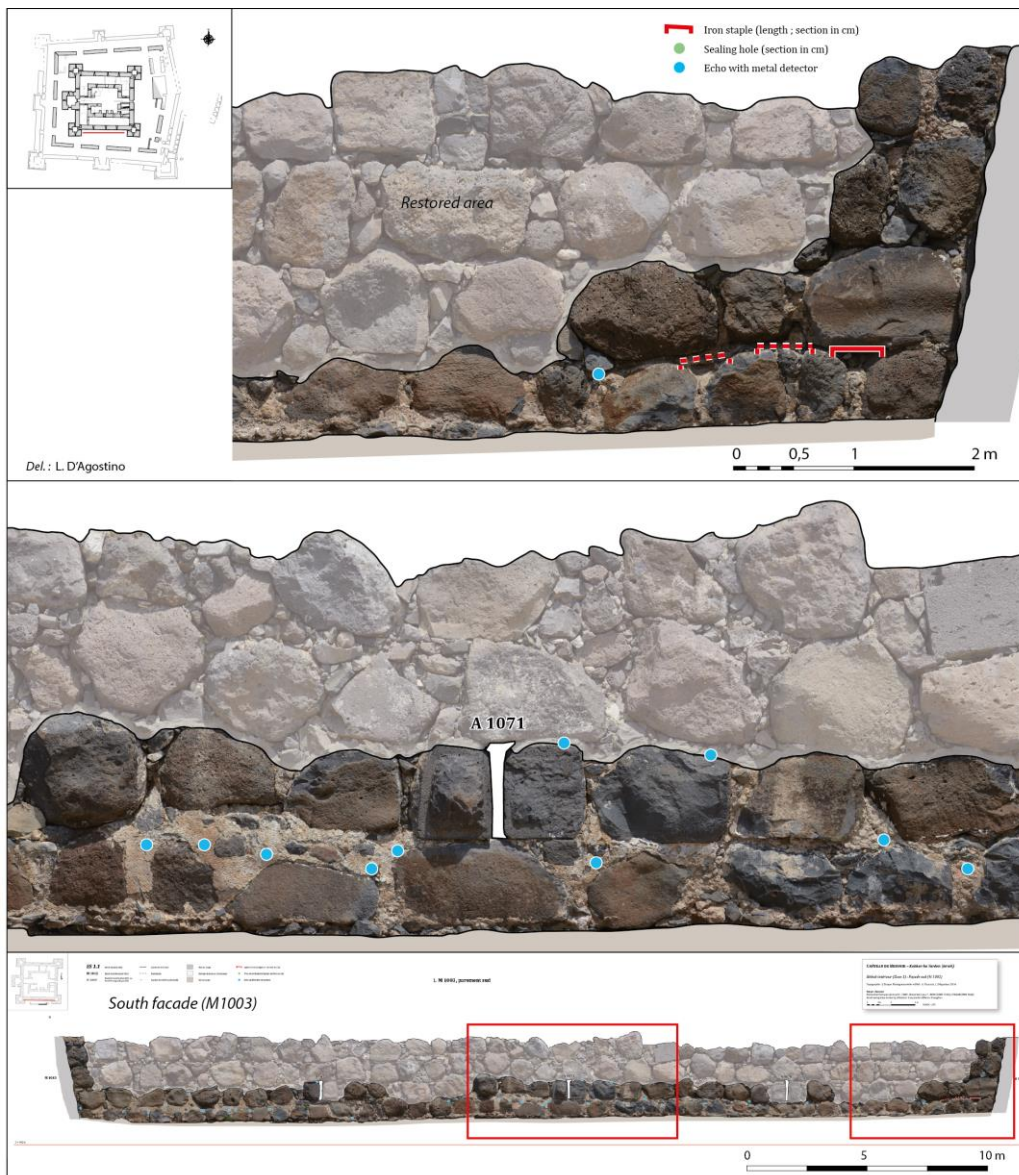
**Fig. 6 - Localization of the staples and of the echoes with metal detector in the external siding of the southern wall (M 1003) of the central building of Belvoir Castle (© L. D'Agostino).**

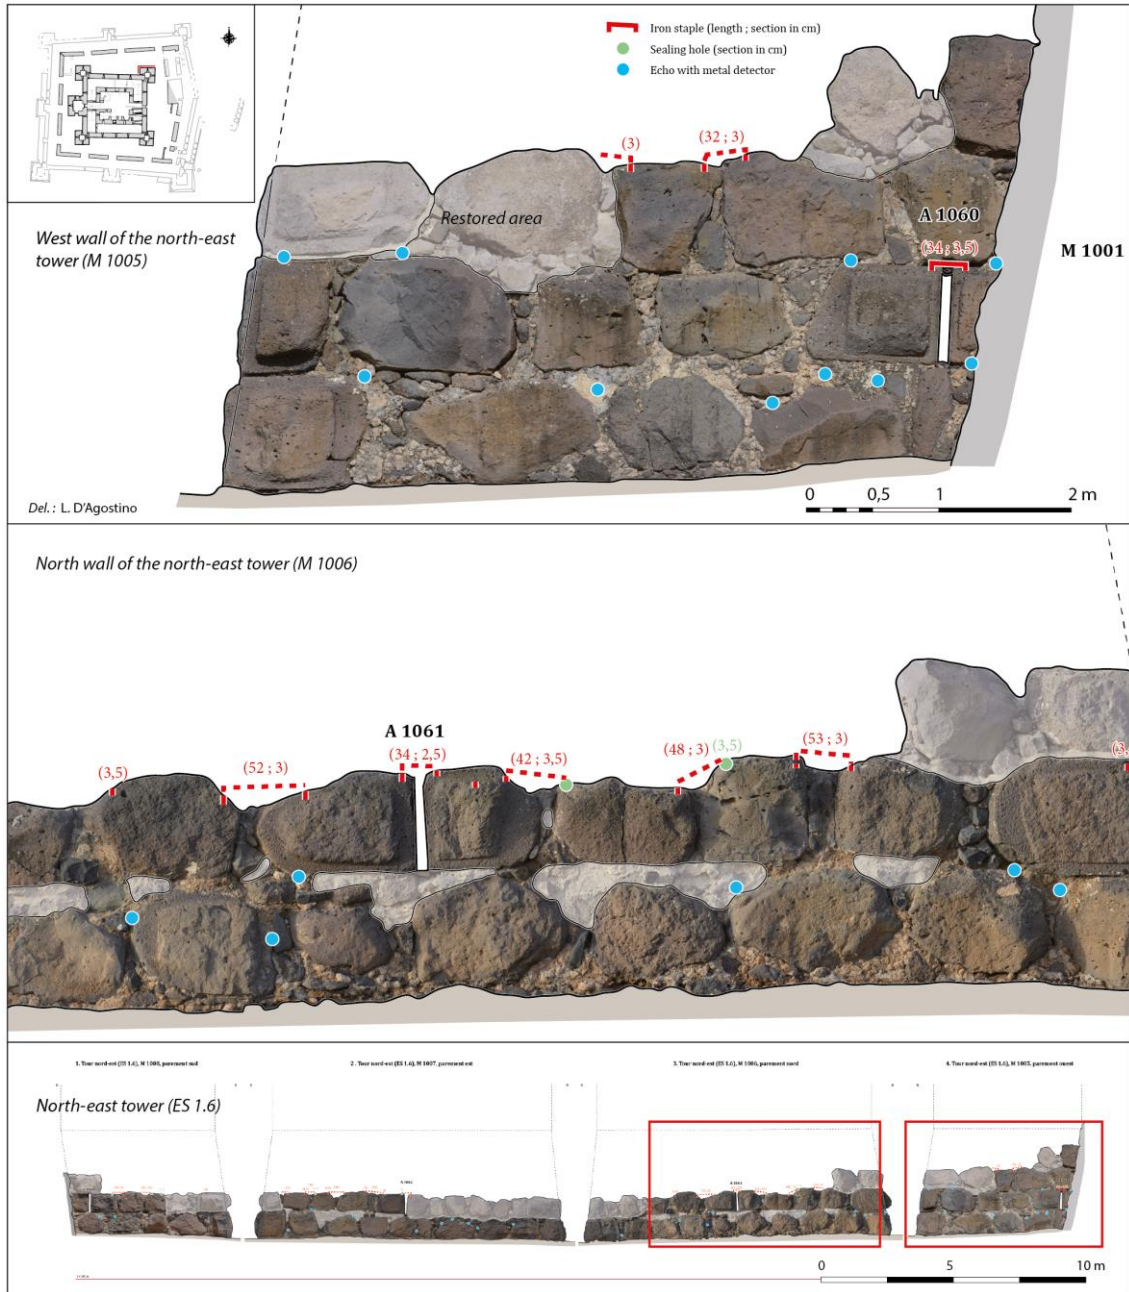
**Fig. 8 - Localization of the staples and of the echoes with metal detector in the north-east tower of the central building (© L. D'Agostino).**

In the central building, staples are observed only on the external facings of the peripheral walls of the reduct and towers, only at the basalt embankments' level. No staple has ever been seen at the level of the large limestone brickwork facings. They are easily spotted and almost systematically present at the level of the arrow slits, where they connect the arrow slits' jambs on the soffit of the lintels. They can be observed very regularly on the towers straddling the corners of the central building, more loosely on the façades. However, they are regularly visible at the clamping points of the towers and the façades. The most favorable areas are the leveling courses of the walls, where the top faces of the blocks are bare; elsewhere, mortar on the joints makes their observation more difficult (**Fig. 8**).

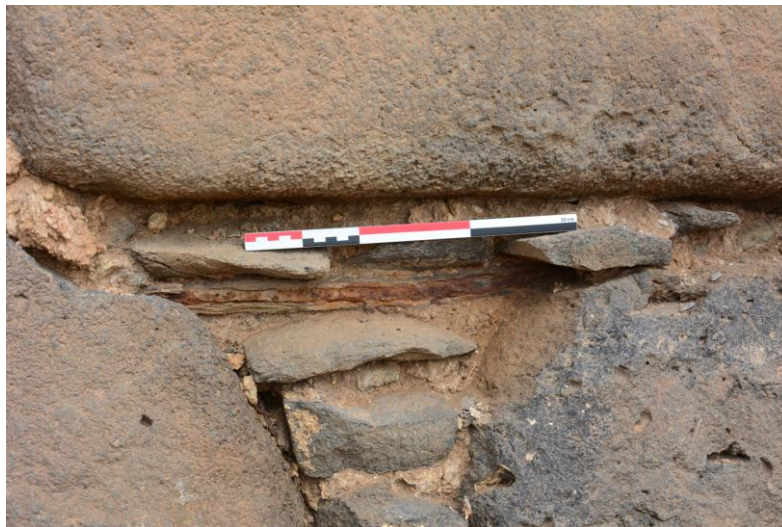
**Fig. 9 – Staple connecting the upper side of two basalt blocks (© L. D'Agostino).**

Moving apart the facings, restored after the castle was cleared, allows for some counting. On the south façade (M 1003), on the first course, which is 37.80 m long and consists of 43 blocks, four staples are attested and 23 echoes were perceived (**Fig. 9**). On the less well-preserved second course, four other echoes have been detected. On the eastern façade (M 1002), on the first course, 8 staples are attested, as well as 17 echoes, on a length of 36.50 m and 36 large basalt blocks (**Fig. 10**). The towers give out even more information and show careful stapling. The northeast tower reveals 20 attested staples and 30 echoes, on all the courses of each wall, particularly at the level of the quoining with the façades (**Fig. 11**). On the first course of the north wall (M 1006), made up of 10 blocks, 8 echoes have been detected; on the second course, made up of 11 blocks, 7 staples are attested. On the eastern wall (M 1007), on the first course, made up of 10 blocks, 9 echoes have been detected; on the second course, made up of 13 blocks with only 5 in place, 5 staples are attested. The south-eastern tower, preserved on only two courses, shows an equally large number of staples with 36 staples attested and 37 echoes.

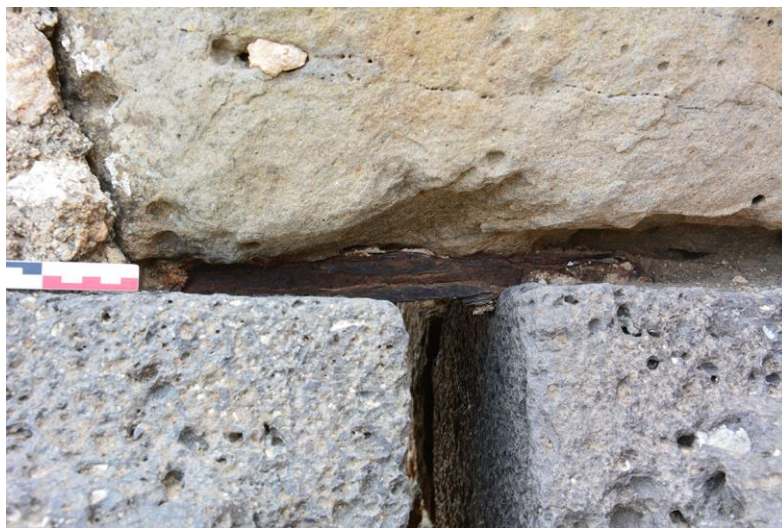
**Fig. 10 – Staple disposed under the lintel of an arrow slit. © L. D'Agostino.**

The staples systematically link two contiguous blocks on the single course of a single wall. Some connect two projecting or receding corner blocks, always on the same course, at the junction between two walls. All of the staples observed are sufficiently set back from the face to be hidden by the mortar beds and the joints. Only the staples at the top of the arrow slits were therefore visible across the width of the slit on the soffit of the lintel. The staples are placed horizontally on the top face of the
